## EVALUATION OF CORROSION UNDER INSULATION AND REMAINING LIFE OF CARBON STEEL PIPELINES

Analisis *Corrosion Under Insulation* (CUI) dan perhitungan umur sisa pipa material A-106-B akibat korosi dilakukan berdasarkan standar API 571 dan ASME B31.3 yang bertujuan untuk mengetahui parameter operasional dan lingkungan terhadap terbentuknya CUI pada pipa tersebut sehingga data dan analisa bisa digunakan untuk evaluasi dan tindakan yang diperlukan. Pengujian yang digunakan antara lain uji komposisi kimia menggunakan alat *Positive Material Identification type portable* OES dan XRF, pengujian ketebalan pipa menggunakan *Ultrasonic Thickness* dan mikroskop optik, pengujian deposit korosi pada pipa menggunakan SEM-EDX, dan pengujian kekerasan menggunakan alat *Micro Vickers Hardness Test*. Hasil analisis menunjukkan bahwa pipa tersebut mengalami korosi pada bagian *Outside Diameter* (OD) yang dikategorikan sebagai CUI. Produk korosi pada luar permukaan pipa yang terbentuk adalah  $\text{Fe}_2\text{O}_3$  dan  $\text{Fe}_3\text{O}_4$ . Hasil dari nilai kekerasan pada spesimen dipengaruhi oleh lingkungan sekitar yang menyebabkan spesimen menjadi lebih keras. Perhitungan sisa umur pipa menun

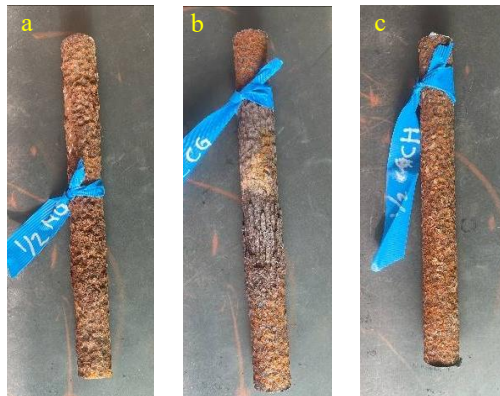
Visual observation of the analyzed pipes based on API 571 standard showed that each pipe had *corrosion under insulation* (CUI) with uneven and peeling surface conditions, rough appearance, unprotected rust, holes, and loose crust covering. The pipe surface conditions are shown in Figure 5.

Figure 5. Pipe surface conditions (a) NG (b) CG (c) CH

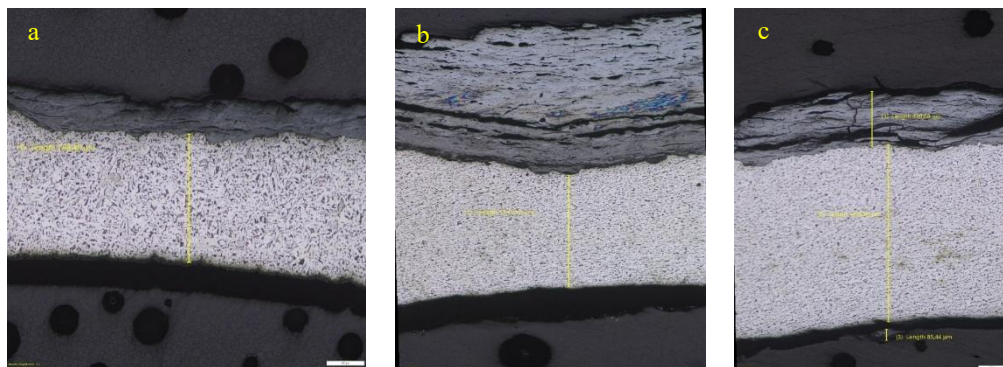
**Figure 6. Pipe thickness using a microscope (a) NG (b) CG (c) CH**

Measurements using microstructure results are more accurate because ultrasonic thickness (UT) testing detects deposits as pipe wall thickness and cannot test areas with corrosion-induced gaps (depressions) that are difficult to detect and test using UT equipment. The thicknesses obtained using a microscope on NG pipes, CG pipes, and CH pipes are 0.71 mm, 1.02336 mm, and 1.42 mm, respectively.

Both the UT analysis results and the microstructure analysis results indicate that the A-106-B pipe has experienced surface thinning due to corrosion, which has caused material loss on the pipe, and the prolonged exposure of the pipe has been in use is also a contributing factor.

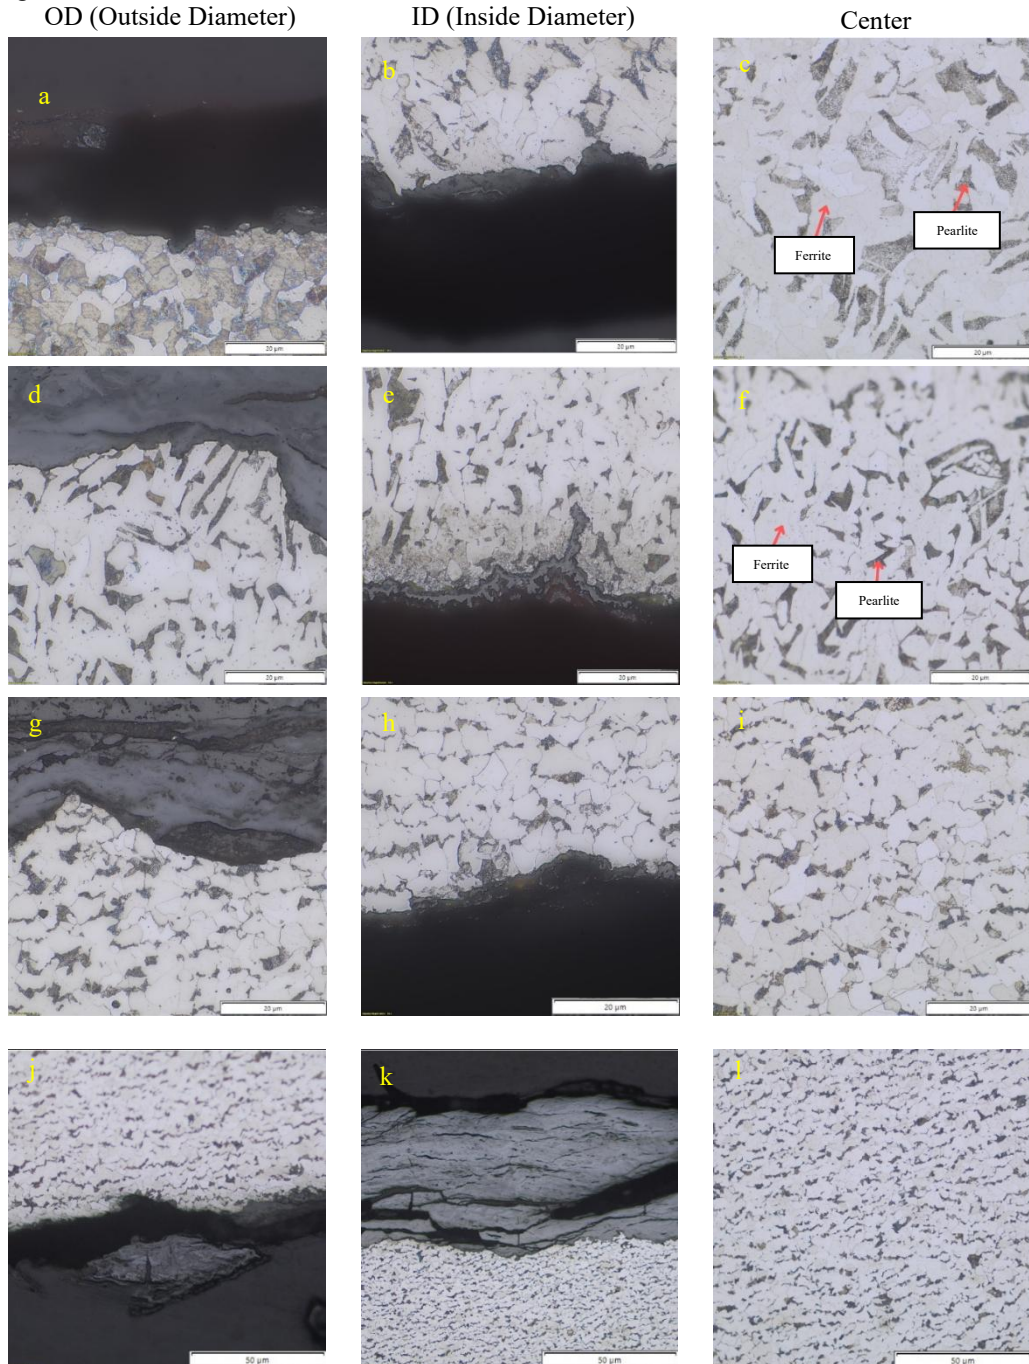
Figure 7. Microstructure of Pipe: (a-c) Spare; (d-f) NG; (g-i) CG; (j-l) CH

In the metallographic test results on the A106-B pipe specimen and the spare specimen, there are dark and light areas, indicating that the dark areas are pearlite phases, while the light areas are ferrite phases. The identification of ferrite and pearlite is consistent with previous metallographic observations of low-carbon steel, in which ferrite and pearlite were observed as the principal microstructural constituents [10]. The ferrite phase affects the material with soft and good magnetic properties in metals, while the pearlite phase affects the material with hard and strong properties. It can be seen that the CH specimen and the CG specimen with the spare specimen do not have significant microstructural results. In the  $\text{Fe}_3\text{C}$  diagram, the phase formed in low carbon steel is 0.148% with ferrite and pearlite phases in the CH specimen and 0.158% in the CG specimen. For the NG sample, the OD of the sample pipe was corroded and had corrosion products on the pipe surface. This could have occurred due to humid environmental conditions, which triggered oxidation and reduction reactions, resulting in rust products adhering to the pipe surface. In addition, there were also corrosion products on the ID, which were likely caused by the flow of pipe fluid. The fluid flowing through the pipe is the outlet from the hydrogenerator, namely sulfur compounds ( $\text{H}_2\text{S}$ ). The corrosion that is likely to occur on the ID section is sulfidation corrosion. This type of corrosion is caused by  $\text{H}_2\text{S}$  gas that forms salt vapor, and is also supported by high temperatures, around  $230^\circ\text{C}$ .

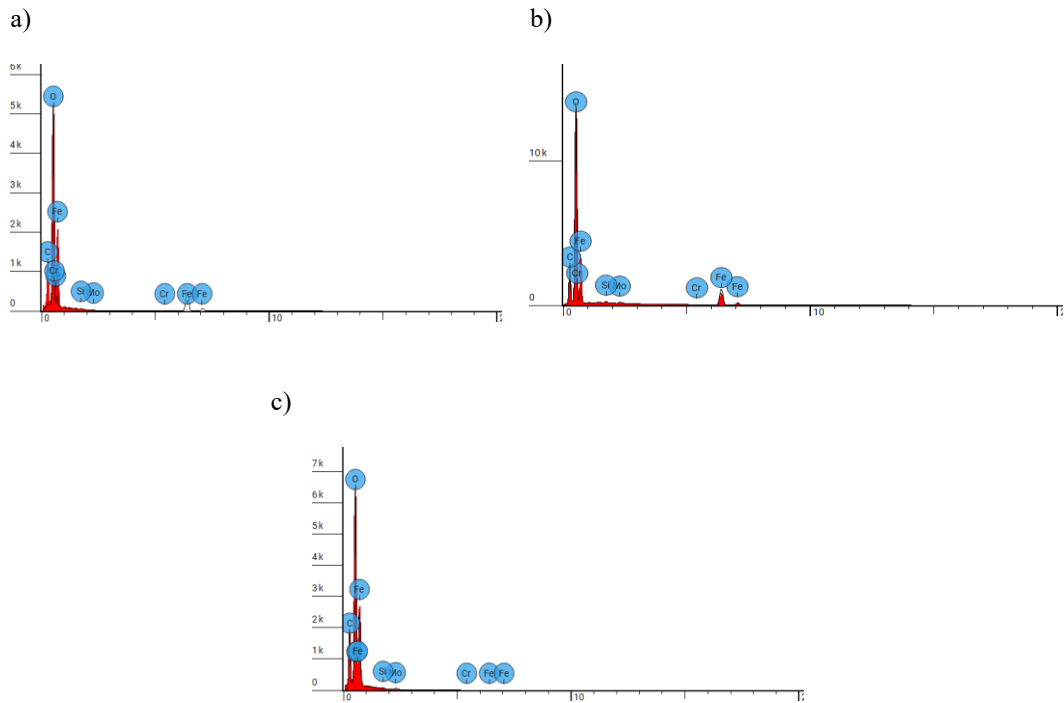
**Figure 8. SEM-EDX analysis of corroded pipes: (a) NG; (b) CG; (c) CH**

Based on the SEM-EDX test results taken from the outer diameter of the pipe (OD), the deposit results on the A-106-B pipe show that the three main elements with the highest percentages are iron (Fe), carbon (C), and oxygen (O). The presence of a fairly high oxygen content of 44.934%wt in the corrosion product indicates the oxidation of iron, which forms iron oxide products such as  $\text{Fe}_2\text{O}_3$  or  $\text{Fe}_3\text{O}_4$ . Exposure of insulated A-106-B pipes to water will increase the rate of corrosion because water can be trapped in the pipe insulation, making it difficult to dry and causing increased moisture in the pipe. Water that has reacted with oxygen will form  $\text{OH}^-$  ions which, when reacting with  $\text{Fe}^{2+}$  or  $\text{Fe}^{3+}$ , will form  $\text{Fe}(\text{OH})_2$  or  $\text{Fe}(\text{OH})_3$ . When it dries or settles on the pipe, it will form  $\text{Fe}_2\text{O}_3$  or  $\text{Fe}_3\text{O}_4$  as corrosion products. The presence of carbon (C) from contaminants attached to the deposits is thought to originate from the grinding process during metallographic testing.
