## ANALYSIS OF THE IMPACT OF FLOOD ON RESIDENTIAL BUILDING DAMAGE IN RAWANG SPREAD DISTRICT, SUNGAI PENUH CITY, JAMBI

### ABSTRACT

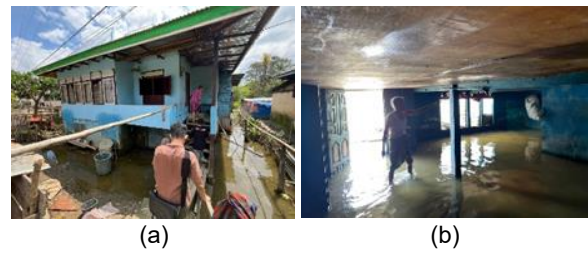
**Figure 2.** Flood Conditions, (a) Outdoor, (b) Indoor  
(Source: Author Observation, 2024)

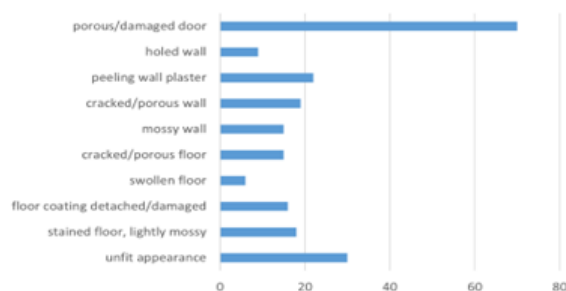
Based on observations and interviews, the majority of visible architectural damage includes damage to doors and windows, affecting 81%, damage to plaster and wall paint, affecting 25%, and finishing appearance that is deemed unfit, affecting 36%. More detailed data on architectural damage complaints can be seen in figure 8.

**Figure 8.** Architectural Damage Types Data  
(Source: Field Observation, 2024)

- Architectural Aspect:** Future house designs should be adjusted to flood potential, such as by raising doors and ventilation above ground level. It is also recommended to use finishing materials that are easy to clean and resistant to moisture, such as ceramic tiles or ACP (Aluminum Composite Panel) on the lower walls.

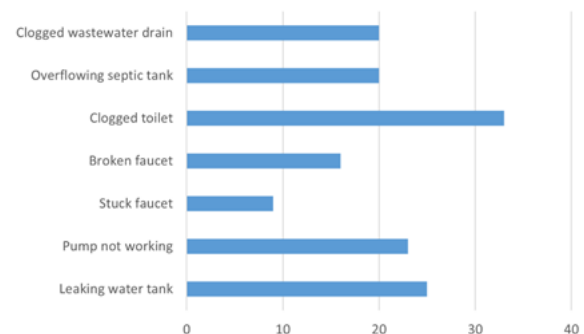
The assessment of utility damage was conducted on buildings that had proper sanitation access, totaling 67 respondents. Out of 86 buildings, 8 buildings experienced total collapse in the bathroom/toilet area. Based on observations and interviews, the most common utility damage complaint experienced by residential buildings was clogged toilets, reported by 51% of respondents. The toilet clogs lasted for several days after the flood. Detailed data on utility damage complaints can be seen in figure 9.

**Figure 9.** Utility Damage Types Data  
(Source: Field Observation, 2024)

- Utility Aspect:** Electrical and water installations should be elevated at least 1 meter above the floor surface to avoid flooding. Use waterproof pipes and cables, and ensure that an automatic circuit breaker system is in place to prevent electrical short circuits during flooding.
