Sustainability and friendly circulation path in Sangiran Museum Sragen Indonesia

Seruni Inas Hanendya¹, Nur Rahmawati Syamsiyah^{2,*}

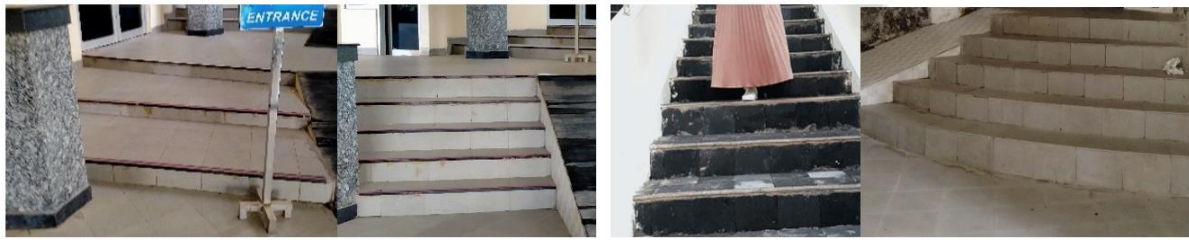
1. Optrade's height is 10 cm, and antrade's wide is 30-60 cm. Stairs with a height < 15 cm are not according to the rules used at the entrance and exit of the showroom, as shown in Figure 6 (a).

- Optrade's height 17-18 cm, and antrade's wide 30-35 cm. Stairs are used at the showroom entrance (Figure 6.b), and to ascend to the mosque. This mosque staircase there is a landing after 20 and 26 steps. A large number of steps and the length of the landing is long, some visitors become tired after passing through these stairs, as shown in Figure 6 (c).
- Optrade's height 22 cm, and antrade's wide 30 cm. Stairs that have a height > 18 cm and are not according to the rules used at the showroom exit, as shown in Figure 6 (d) specimens

Figure 6. The height and width of the stairs are used to categorise the shape of the stairs.
