## ARCHITECTURAL DISTRESS: PRESSURE ON USER COMFORT AT THE TANJUNG DUREN BRT STOP

**Ariz Fantro Larosa**

**Muhammad Siam Priyono Nugroho**

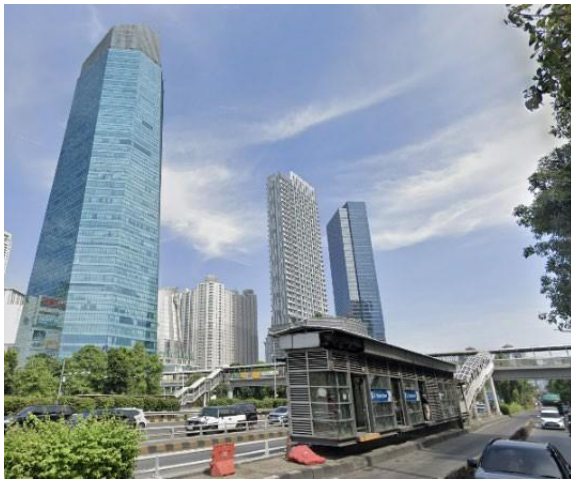
**Figure 2.** Tanjung Duren Halte (East) and Pedestrian Overpass with Existing Buildings  
(Source: Google Maps, 2025)

One of the key nodes in this system is the Tanjung Duren BRT Stop, which is located in a mixed-use area characterized by exceptionally high activity intensity. Based on the area map (Figure 1) and existing site conditions (Figure 2), the BRT Stop lies within walking distance of metropolitan-scale commercial centers, vertical residential developments, and office complexes, including Central Park, Central Park 2, and Mall Taman Anggrek. This combination of these surrounding functions generates a near-continuous flow of users throughout the day, with substantial increases during morning and evening peak periods. As a result, the BRT Stop as a transit node that operates under sustained occupancy pressure.

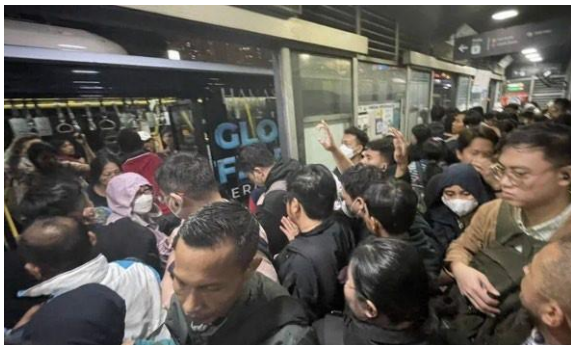
**Figure 3.** Interior conditions of the Tanjung Duren Transjakarta BRT Stop during Rush Hour  
(Source: Author's Document, 2025)

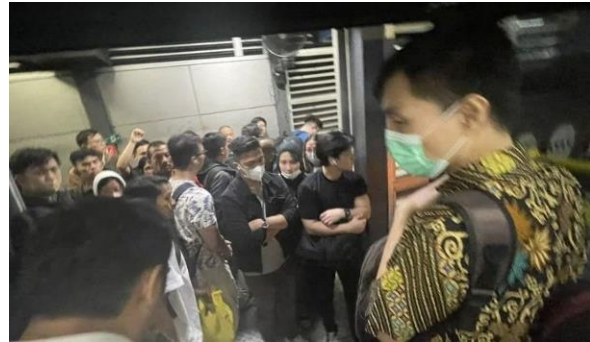
**Figure 4.** Passenger crowding at the boarding area blocking access for alighting passengers, causing bidirectional movement conflict  
(Source: Author's Document, 2025)

These conditions are further intensified by a spatial configuration that does not adequately respond to actual user demand. A circulation bottleneck of approximately  $\pm 0.9$  m occurs at the transition between the pedestrian overpass, the unpaid zone, and the platform, creating queue accumulation that extends back onto the overpass (Figure 4). In addition, the absence of a clearly defined separation between incoming and outgoing passenger

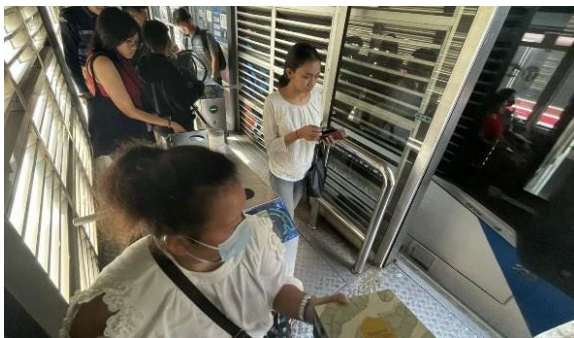
**Figure 8.** Location of Tap In/Out Machines Adjacent to the Platform  
(Source: Author's Document, 2025)

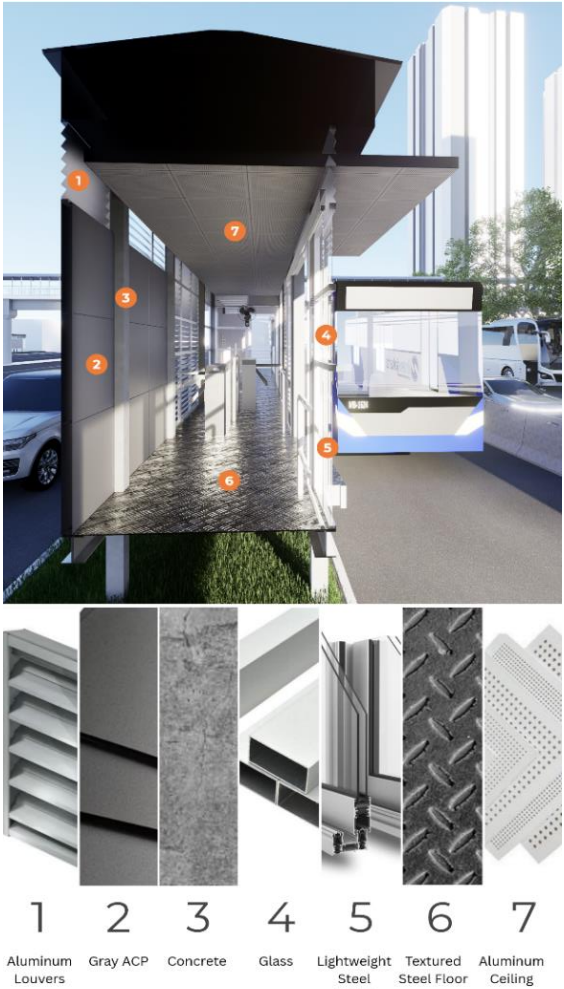
**Figure 15.** Materials at Tanjung Duren Shelter  
(Source: Author's Field Survey, 2025)

Based on the material composition (Table 4), the building envelope of the Tanjung Duren BRT Stop is dominated by conductive materials with high heat storage potential. Aluminum composite panels (ACP) account for 31.32%, of the envelope surface, followed by extruded aluminum louvers at 30.28%, and glass walls at 29.32%, meaning that these elements collectively comprise more than 60% of the enclosure.

| No. (Fig. 15) | Element / Material | Area (m <sup>2</sup> ) | (%) |
| 1 | Extruded aluminum louvers | 31.06 | 30.28% |
| 2 | Aluminum composite panel / ACP (light gray) | 32.13 | 31.32% |
| 4 | Glass wall (steel frame) | 30.08 | 29.32% |
