## EVALUATION OF EDUCATION BUILDING BASED ON HEALTHY BUILDING ASPECTS (AIR CIRCULATION, HUMIDITY, NATURAL LIGHT INTENSITY)

The case study is the Mochtar Riady Plaza Quantum (MRPQ) Building in the Faculty of Engineering, Universitas Indonesia (see Figure 1).

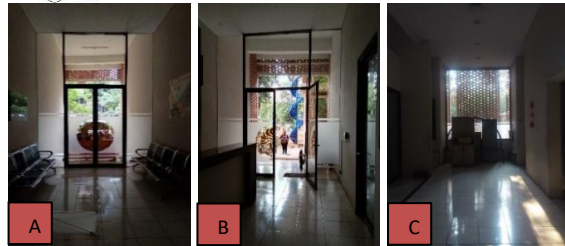
**Figure 2a.** Some Damp and low light areas in the corridor on the 1<sup>st</sup> Floor (A, B,C)

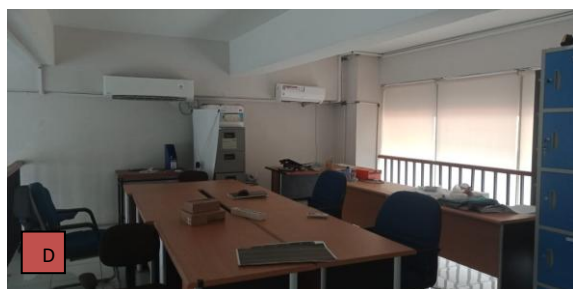
**Figure 2b.** one of the rooms in room discussion in 2<sup>nd</sup> floor (D)
