VISUAL COMFORT ANALYSIS OF OFFICE BUILDINGS IN THE *GEDHONG HINGGIL*, RECTORATE BUILDING OF WIDYA MATARAM UNIVERSITY

This research aims to analyze work space comfort based on visual comfort standards using methods according to SNI 03-6572-2001 case study: Widya Mataram University Campus Rectorate Building, Dalem Mangkubumen, whether it meets visual comfort for room users who work in the rectorate room.

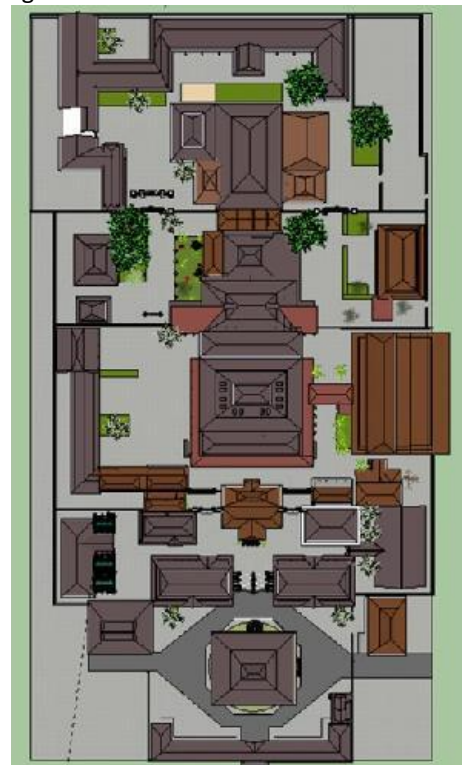
Figure 1. Block Plan in Mangkubumen
 (source: <https://docplayer.info/docs-images/73/69475546/images/3-3.jpg>)

The spatial layout of the Widya Mataram University Rectorate Building is divided into 3 areas including the left wing, the core building directly connected to the front terrace and the right wing. A spatial layout designed in this way produces less than optimal results because the central room, which is the living room, the chancellor's room, the vice-chancellor's room and the meeting room cannot get direct access to natural lighting. This situation means that the amount of light in the room is still very low or below the visual comfort standards for office buildings.

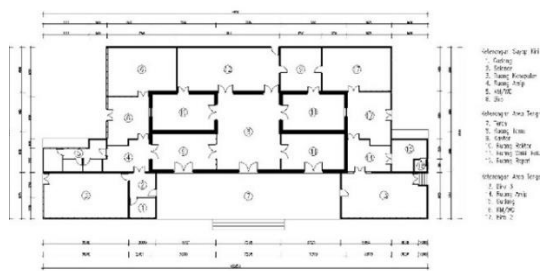
Figure 2. Plan of the rectorate
(source: Author's Document, 2022)

The orientation of the rectorate building is to the south and is directly connected to the Pendopo Dalem Mangkubumen. This building extends from east to west with the longest facade facing the north and south sides. The facade of the building is equipped with the most light openings in the east, south and west, while the north does not have light openings because it is directly connected to the Nehru room. The most light openings are located in the west, south and east, while the north has no light openings. With this orientation on the east and west sides and the openings on this side are quite optimal because the size of the light openings can be maximized to support the amount of light provided for the visual comfort of the users, especially in the computer room, bureau 1, bureau 2, bureau 3, warehouse.

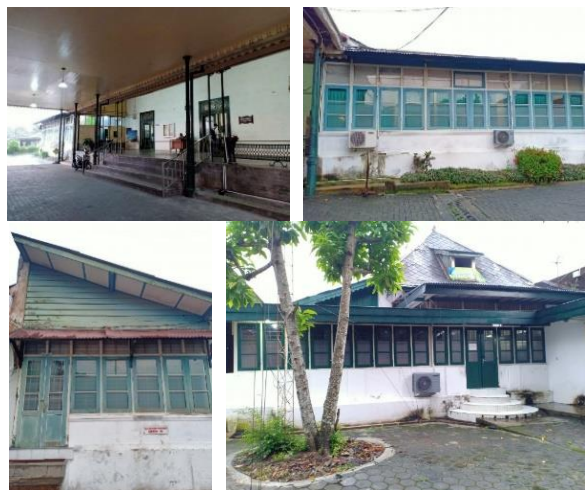
Figure 8. Photo of the rectorate opening
(source: Author's Document, 2022)

The objects measured in this research are work spaces and offices. The Rectorate Building of Widya Mataram University is the object of observing visual comfort in the office. The scope taken is the entire work space within the rectorate. Some rectorate rooms have quite large open windows but still use artificial light (lamps) and also use cloth curtains. Meanwhile, the central room of the building does not have any windows at all, which can affect the visual comfort in the room.

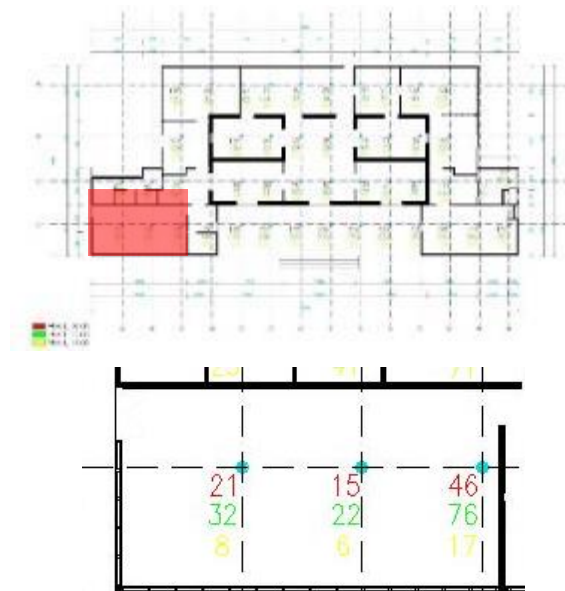
Figure 9. Computer room plan
(source: Author's Document, 2022)

From the results of measuring the light intensity in the computer room, the results obtained from measurements at 3 measurement points in the computer room with the condition of the computer room only using natural light, according to the measurements obtained, the results did not meet the requirements of SNI standards. The highest light intensity occurs at 12.00 where the room receives a greater average of light than at 9.00 and 16.00. Another factor that influences the lack of visual comfort in the computer room is the curtains being closed because the room is not being used.

The results of this study which are below standard will have an impact on visual discomfort for users of the room during the work process. With these conditions, additional responses are needed to create visual comfort for users while working by increasing the light intensity in the room by adding artificial lighting (lamps).

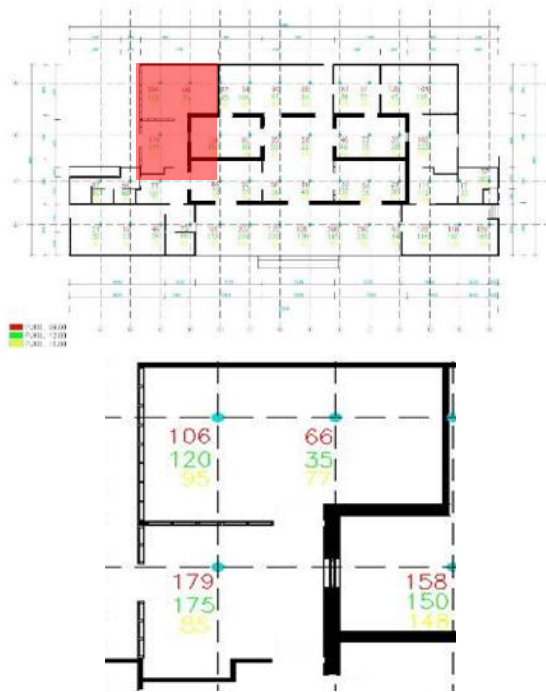
Figure 10. Bureau room plan 1
(source: Author's Document, 2022)

The results of measurements of light intensity in the Bureau 1 room were obtained from measurements at 3 measurement points with room conditions that used artificial light (lamps) and natural light. According to the measurements obtained the results did not meet the requirements of SNI standards. There are quite a lot of openings in the Bureau 1 room, but the results of measurements in the field of natural light entering the room are still very lacking.

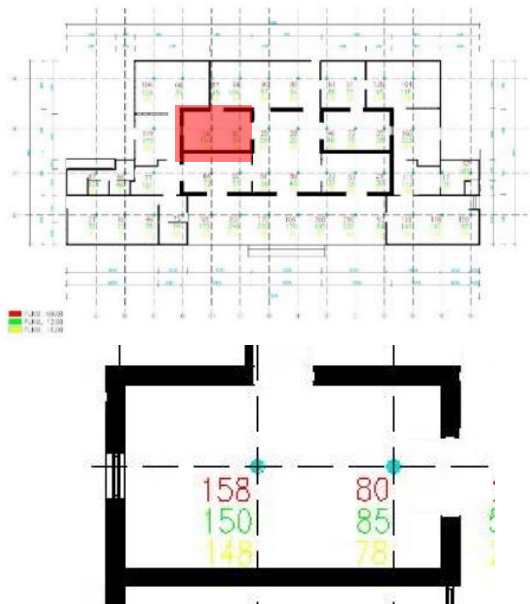
Figure 11. Rector's room plan
(source: Author's Document, 2022)

The results of measuring light intensity in the Rector's Room were obtained from 2 measurement points in the Rector's Room with room conditions that only used artificial light (lamps), the results obtained did not meet the requirements of SNI standards. The Chancellor's Room does not have any openings that directly face the outside of the room so this room only uses artificial light (lamps). This room is the original building of the prince's house whose layout has not been changed. The point of greatest intensity in the Chancellor's room is in the work desk area.

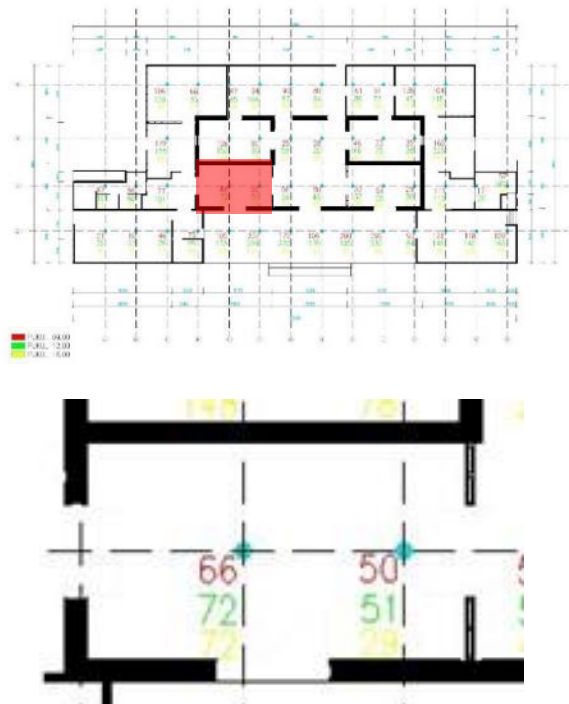
Figure 12. Front office space plan

The results of measuring the light intensity in the front office room were obtained from measurements at 2 measurement points in the rector's room with room conditions that used artificial light (lamps) and door openings that directly faced the front terrace. According to the measurements obtained the results did not meet the requirements of SNI standards. This front office room has a door opening that directly faces the front terrace. However, the terrace is too wide so not much light enters the room. The average measurement for each hour shows almost the same results and is not much different.

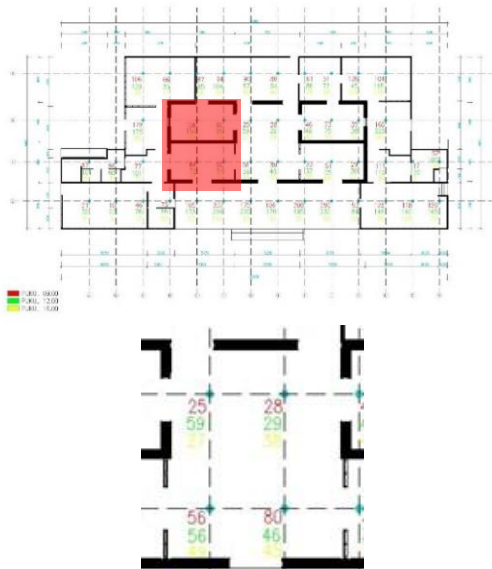
Figure 13. Living room plan
(source: Author's Document, 2022)

The results of measuring light intensity in the living room were obtained from measurements at 4 measurement points in the living room with room conditions that used artificial light (lamps) and door openings that directly faced the front terrace. According to the measurements obtained the results did not meet the requirements of SNI standards. This living room has a door opening that directly faces the front terrace. However, openings cannot increase the level of light entering the room. The average measurement for each hour shows almost the same results and is not much different.

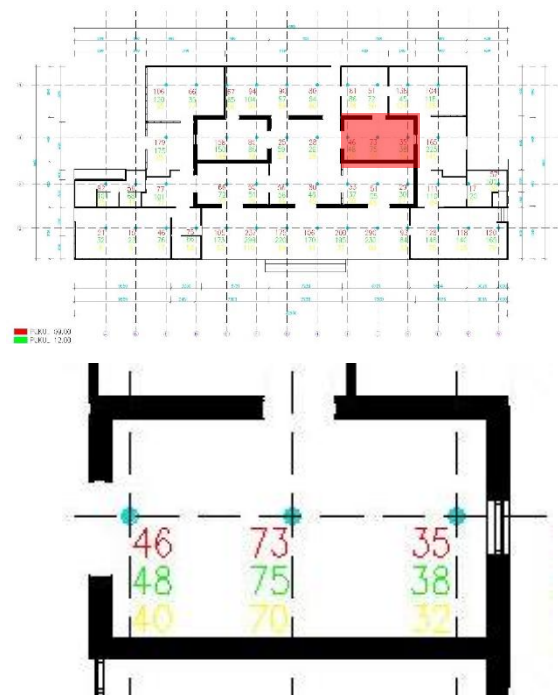
Figure 15. Vice chancellor III room plan

The results of measurements of light intensity in the Vice Chancellor I's room were obtained from measurements at 3 measurement points in the Vice Chancellor I's room with room conditions that only used artificial light (lamps), according to the measurements obtained the results did not meet the requirements of SNI standards. The Vice Chancellor I's room does not have an opening that faces directly outside the room so this room only uses artificial light (lamps). This room does not have windows that directly face the outside area of the building. The average measurement for each hour shows almost the same results and is not much different.

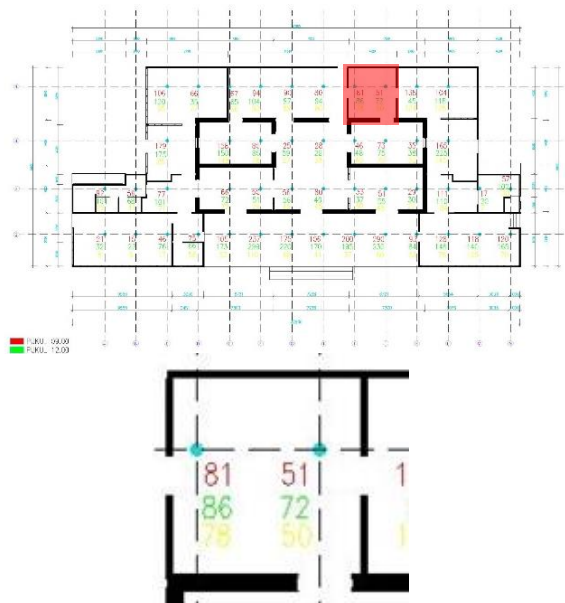
Figure 16. Vice chancellor II room plan
(source: Author's Document, 2022)

The results of measurements of light intensity in the Vice Chancellor Ijusufi room were obtained from measurements at 2 measurement points in the Vice Chancellor II room with room conditions that only used artificial light (lamps) according to the measurements obtained the results did not meet the requirements of SNI standards. The Vice Chancellor II's room does not have any openings that face directly outside the room so this room only uses artificial light (lamps). This space is very closed and has no window openings at all. The average measurement for each hour shows almost the same results and is not much different.

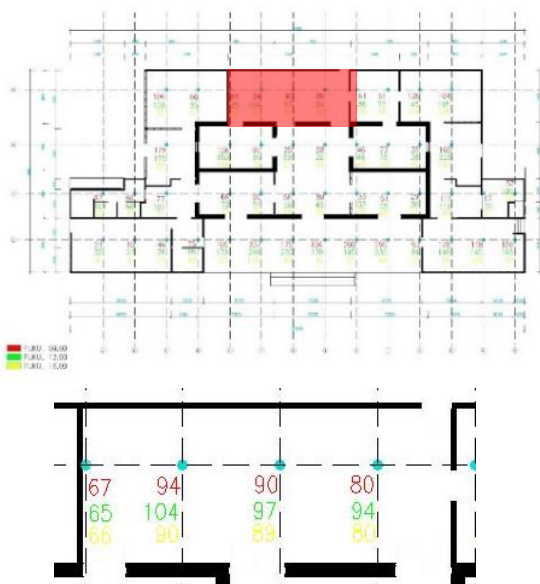
Figure 17. Meeting room plan
(source: Author's Document, 2022)

The results of measuring light intensity in the meeting room were obtained from measurements at 4 measurement points in the meeting room with room conditions that only used artificial light (lamps), according to the measurements obtained the results did not meet the requirements of SNI standards. The location of the meeting room which is at the very back of the building does not have any openings that face directly outside the room so this room only uses artificial light (lamps). This meeting room is directly adjacent to the Nehru room on the north side so there are no direct openings to the outside. The average measurement for each hour shows almost the same results and is not much different.

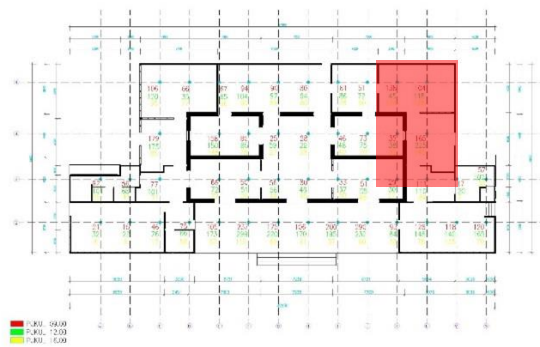
Figure 18. Plan of bureau room 2
(source: Author's Document, 2022)

The results of measurements of light intensity in the Bureau 2 room were obtained from measurements at 3 measurement points in the Bureau 2 room with room conditions that used artificial light (lamps) and natural light. According to measurements the results obtained on average did not meet the requirements of SNI standards. There are quite a lot of openings in the Bureau 2 room, but the results of measurements in the field of natural light entering the room are still very lacking. The canopy in front affects the entry of light into the room so that the light level cannot be maximized.

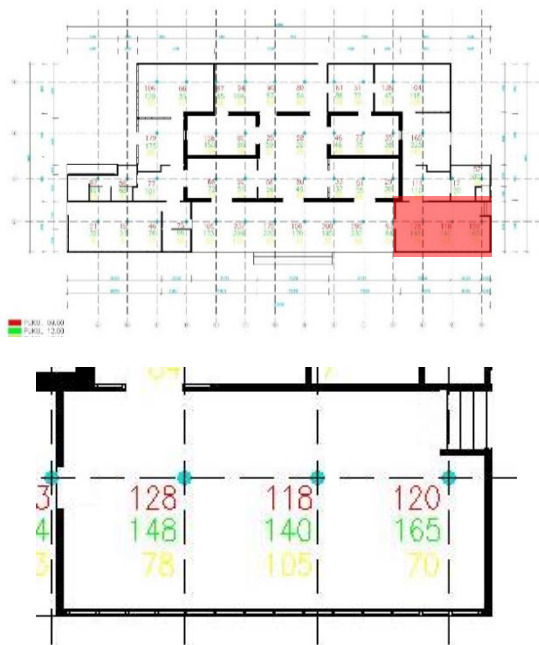
Figure 19. Plan of bureau room 3
(source: Author's Document, 2022)

In the Bureau 3 room, the results obtained from measurements at 3 measurement points in the Bureau 3 room with room conditions using artificial light (lamps) and natural light, according to the measurements obtained, the results on average did not meet the requirements of SNI standards. There are quite a lot of openings in the Bureau 3 room, but the results of measurements in the field of natural light entering the room are still very lacking.
